Final Report
MINE SAFETY EVALUATION
FOR
PROJECT RULISON

By R. L. Bolmer

U. S. Bureau of Mines
Denver Mining Research Center
Denver, Colorado

January 10, 1970

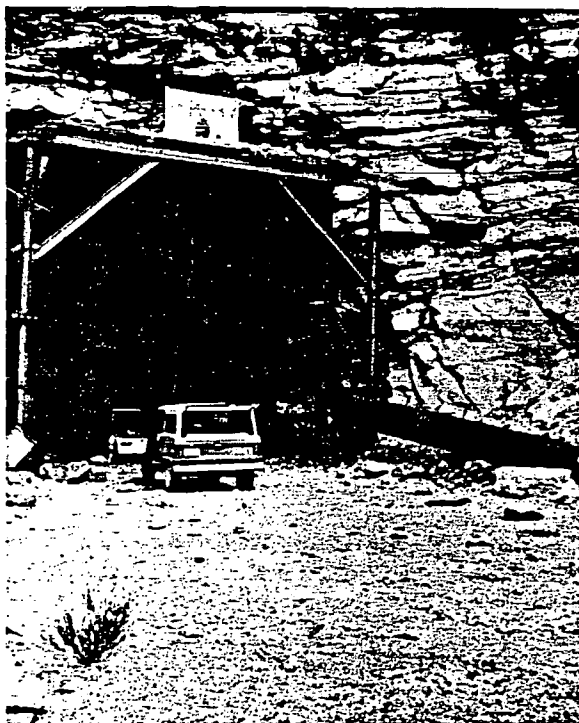
Roof of haulage adit

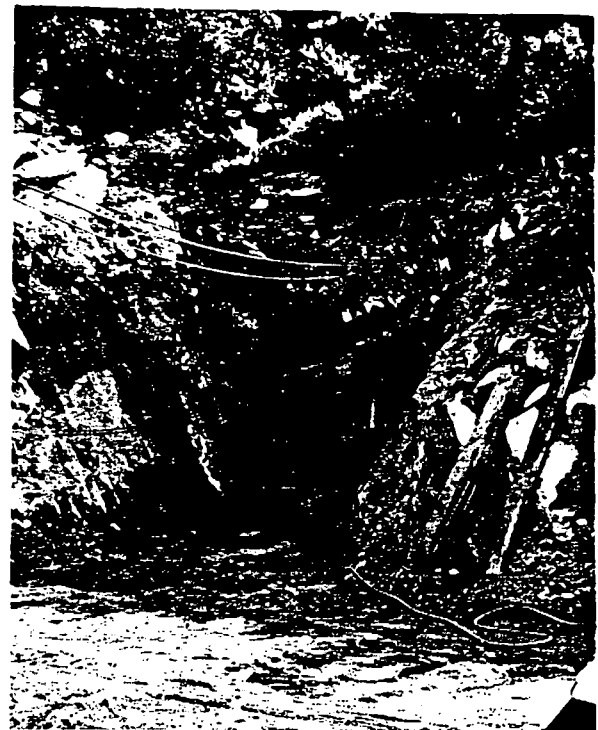
Portal of slope entry in steeply-pitching coal seam.

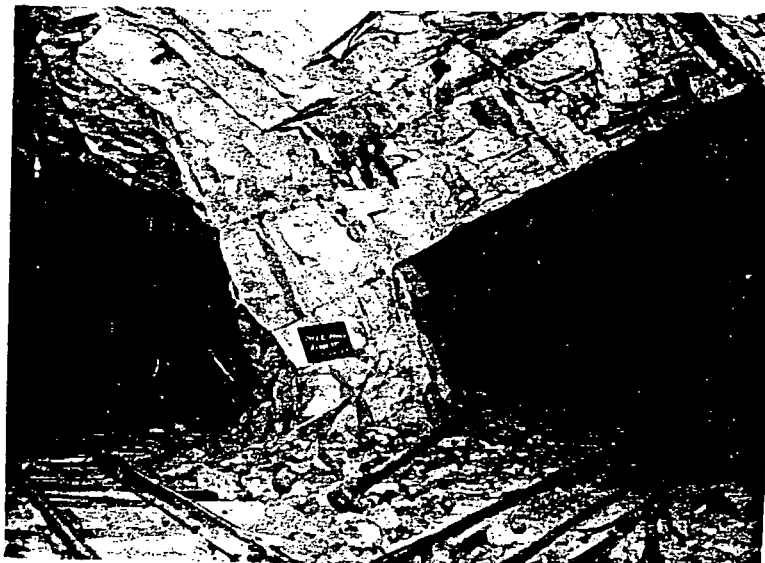
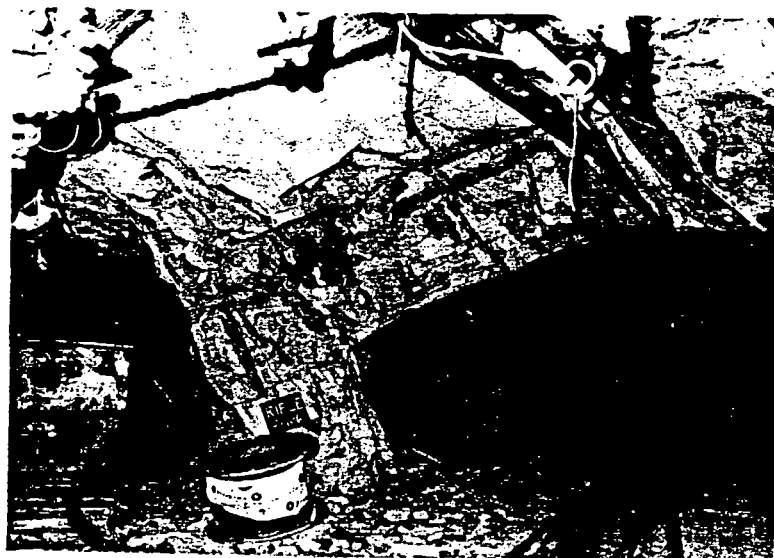
Pillar on A level between
hoist station and inclined shaft

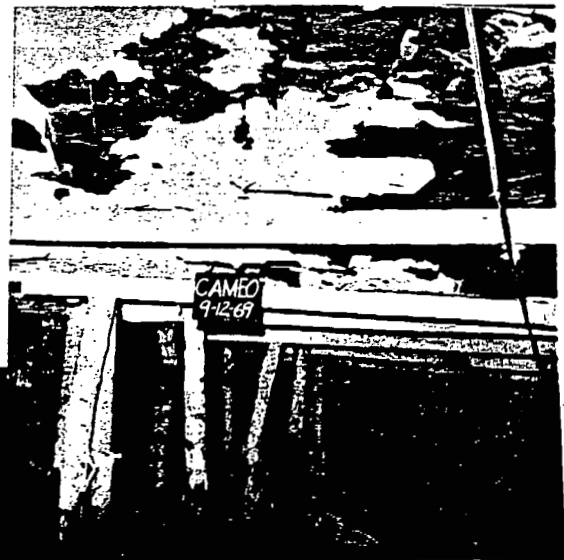
Timbers taking weight of
roof sag and floor heave
in 3rd West haulage entry

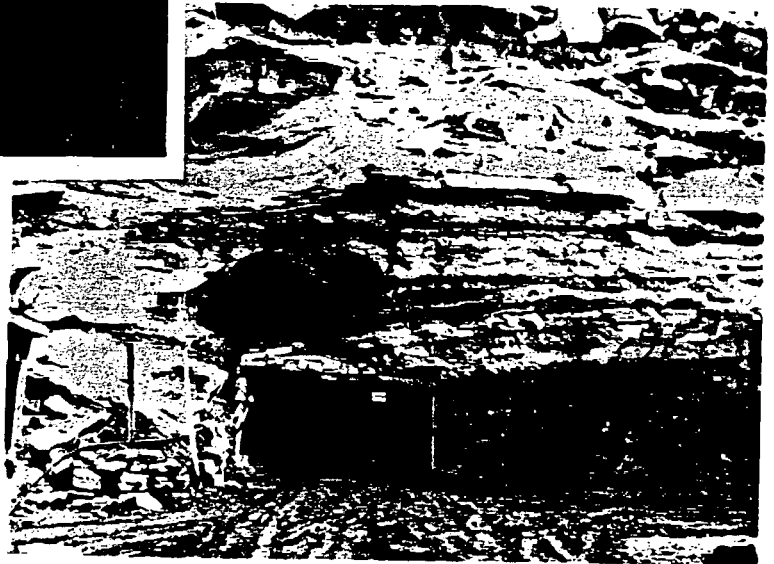
Portal and portal timber
sets of main haulage
entry

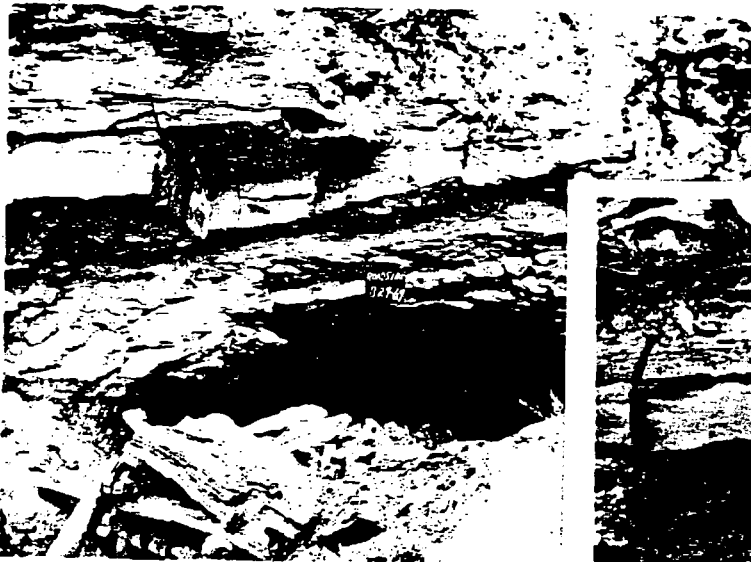
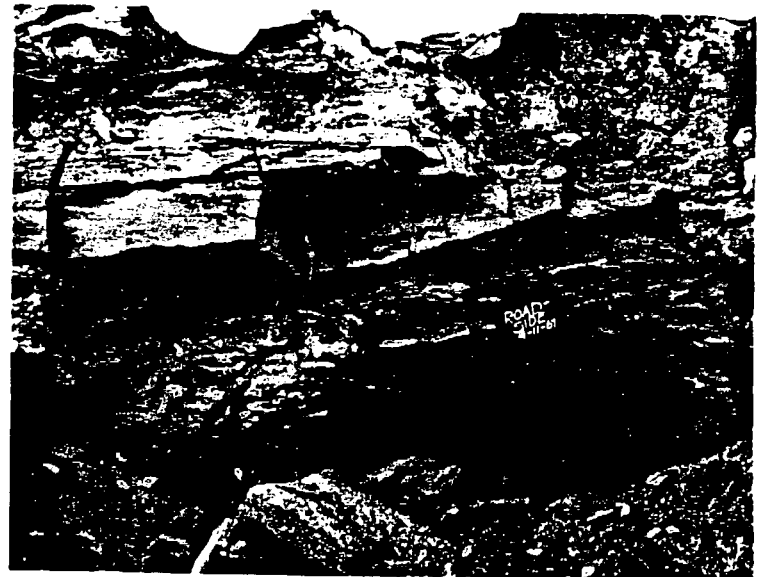
Portal of return airway and emergency escapeway
